**Flood Control Project Maintenance  
Levee Inspections**  
**LMA District Cover Sheet**  
**Spring 2018 Levee Inspection Results**

**Levee District No. 0003 (Glenn County)**

**Levee Inspection Report By Mile - Spring 2018**

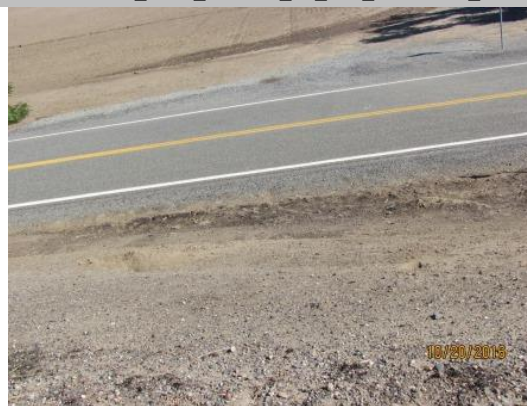
Photo 1 of 1 : SP\_2018\_LD0003\_27\_105\_20180305\_00068.jpg

View of the rodent holes along the landside slope.

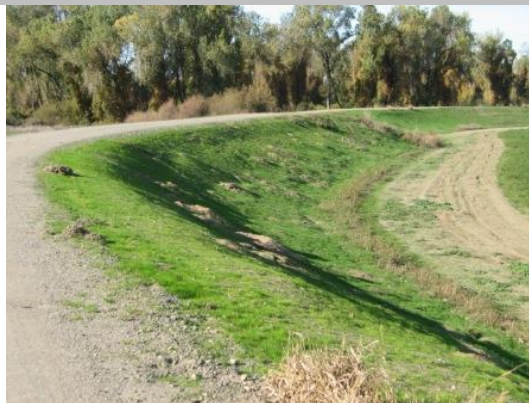
Photo 1 of 1 : SP\_2018\_LD0003\_27\_3\_20180305\_00001.jpg

View of squirrel holes along the landside slope.

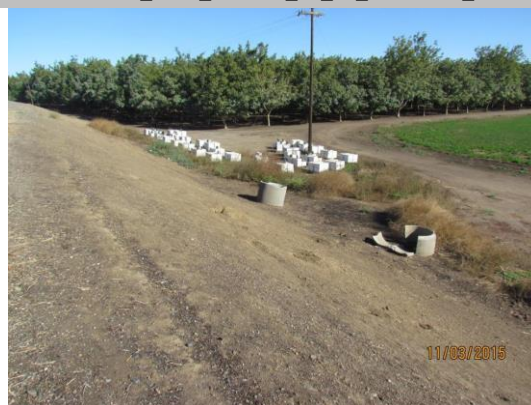
Photo 1 of 1 : SP\_2018\_LD0003\_27\_52\_20180305\_00034.jpg

View of the rodent holes along the landside slope.

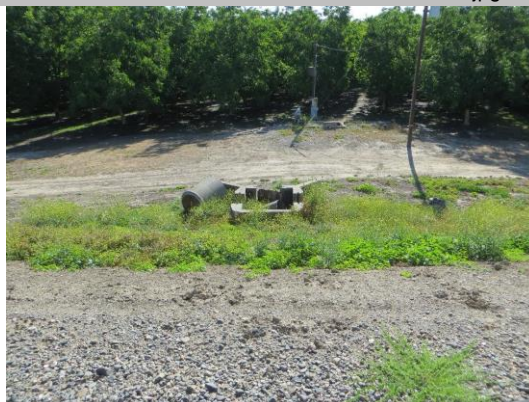
Photo 3 of 3 : UCIP\_SP\_2018\_14573\_24036.jpg

Distribution box on LS toe.

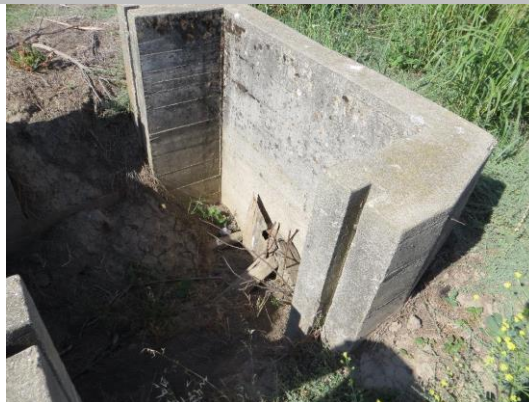
Photo 3 of 3 : UCIP\_SP\_2018\_14577\_24053.jpg

Debris and steel plate blocking inlet on LS toe.

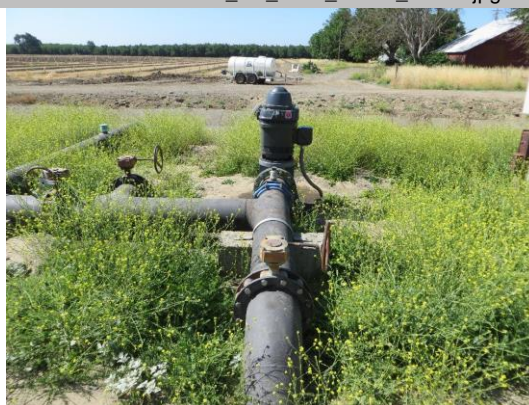
Photo 2 of 3 : UCIP\_SP\_2018\_15144\_24882.jpg

Pump and butterfly valve off LS toe.

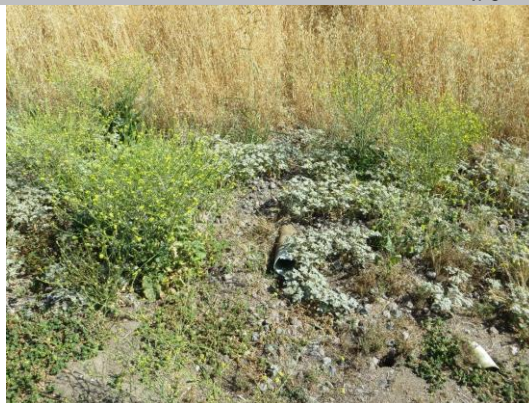
Photo 3 of 3 : UCIP\_SP\_2018\_15144\_24881.jpg

3-inch drain on WS toe (purpose unclear).

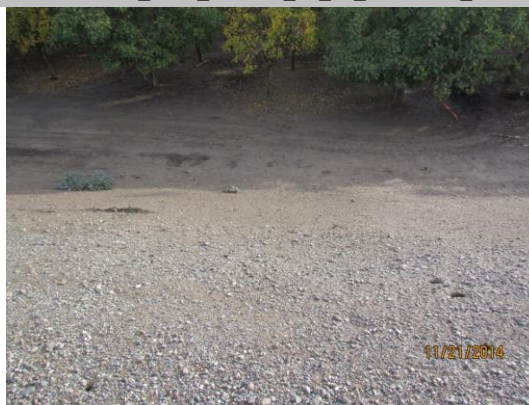
Photo 1 of 1 : SP\_2018\_LD0003\_27\_13\_20180305\_00011.jpg

LM Start	2.35	Rating **	M	Issue No.	13
LM End	2.52	Issue Type +	Ma	Location *	WS
Category	Earthen Levee			GPS Latitude/Longitude	
				Start	End
Item	Animal Control			39.406413 °	39.407248 °
				-121.995993 °	-121.993177 °
DWR ID	DWR_LD0003_01_s_2012_13				
Comment Code					
A3 : No rodents visible, but rodent burrows visible; need to backfill and compact or grout burrows.					
Inspector Comment

View of the rodent holes along the waterside slope.

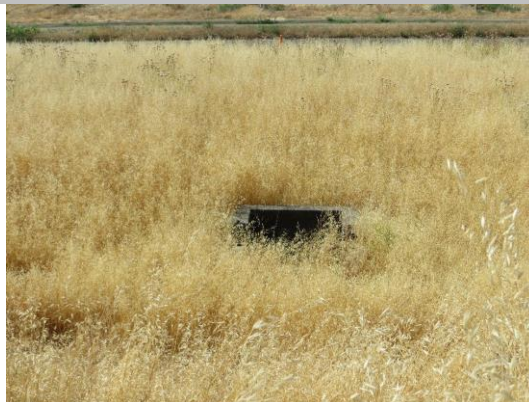
Photo 2 of 3 : UCIP\_SP\_2018\_14582\_24075.jpg

Concrete distribution box on LS toe.

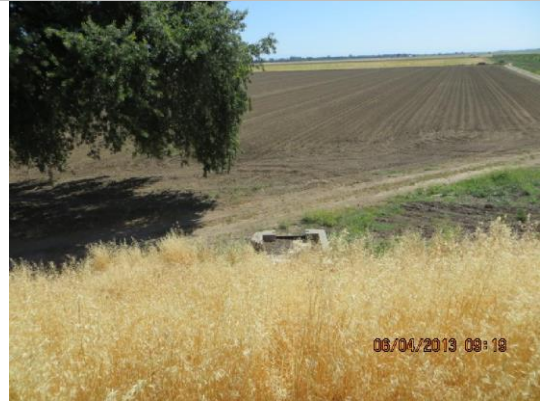
Photo 2 of 2 : UCIP\_SP\_2018\_14584\_24080.jpg

Comment Code						
Inspector Comment						
FS_ID:14584 DS_ID:18829 EP_NO: 9919 Repair Type: Non-Urgent Crossing Status: Indicator Found UCIP Comments: Appears abandoned. Verify it was done corectly. FIELD_STRUCT_DESC: *ABANDONED* 24-inch corrugated metal irrigation pipe through the levee, 16 feet below the crown. Slide gate on the waterside (WS) end. 5-foot by 7-foot concrete distribution box at landside (LS) toe is filled with grout. (Automatic Board Order (ABO) issued as Permit No. 9919, 1974 - Roy and Annie Mills). [Additional Reference(s): DWR Levee Log, 1992. USACE Sacramento O&M Manual 136, March 1960 (HLM 23.43)]. FS Date: 6/4/2013

Distribution box on LS toe.

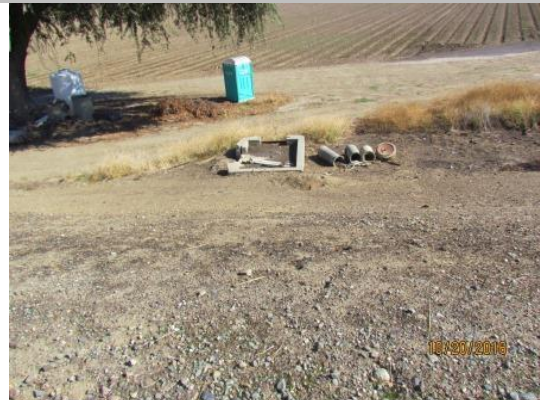
Photo 1 of 1 : SP\_2018\_LD0003\_27\_102\_20180305\_00065.jpg

LM Start	2.98	Rating **	M	Issue No.	102
LM End	2.98	Issue Type +	Ma	Location *	LS
Category	Earthen Levee			GPS Latitude/Longitude	
				Start	End
Item	Animal Control			39.412909 °	39.412909 °
				-121.991446 °	-121.991446 °
DWR ID	DWR_LD0003_01_f_2016_102				
Comment Code					
A1 : Exterminate rodents and backfill and compact or grout burrows.					
Inspector Comment

View of the rodent holes along the landside slope.

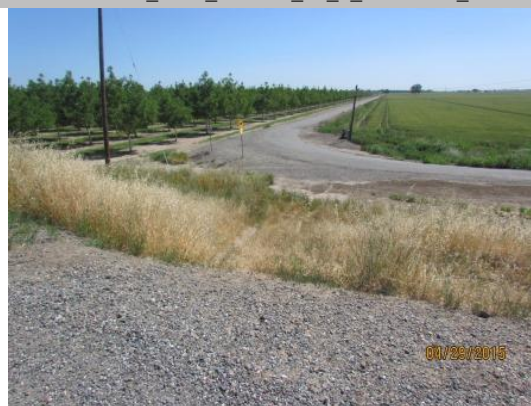
Photo 1 of 1 : SP\_2018\_LD0003\_27\_9\_20180305\_00006.jpg

LM Start	3.39	Rating **	M	Issue No.	9
LM End	3.39	Issue Type +	Ma	Location *	LS
Category	Earthen Levee			GPS Latitude/Longitude	
				Start	End
Item	Slope Stability			39.418382 °	39.418382 °
				-121.992480 °	-121.992480 °
DWR ID	DWR_LD0003_01_s_2012_9				
Comment Code					
S3 : Repair the levee slope damaged by vehicle traffic and prevent access where possible.					
Inspector Comment					
Repair the erosion along the landside slope and prevent vehicle access

View of the vehicle erosion along the landside slope.

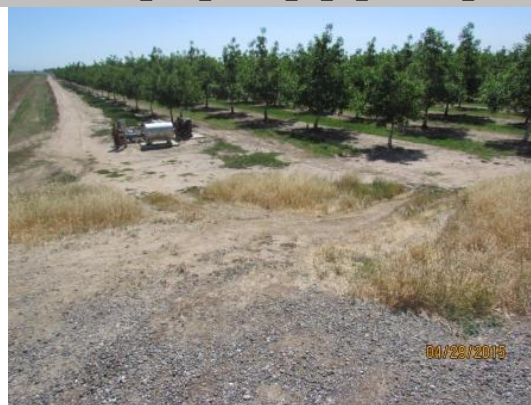
Photo 1 of 1 : SP\_2018\_LD0003\_27\_19\_20180305\_00013.jpg

LM Start	3.76	Rating **	M	Issue No.	19
LM End	3.76	Issue Type +	Ma	Location *	LS
Category	Earthen Levee			GPS Latitude/Longitude	
				Start	End
Item	Slope Stability			39.423747 °	39.423747 °
				-121.991667 °	-121.991667 °
DWR ID	DWR_LD0003_01_s_2012_19				
Comment Code					
S3 : Repair the levee slope damaged by vehicle traffic and prevent access where possible.					
Inspector Comment

View of the vehicle erosion along the landside slope.

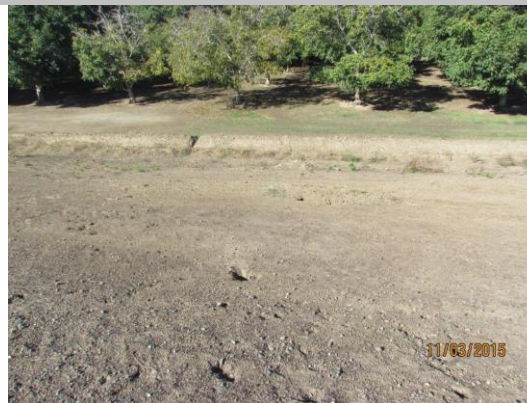
Photo 1 of 1 : SP\_2018\_LD0003\_27\_59\_20180305\_00038.jpg

View of the rodent holes along the landside slope.

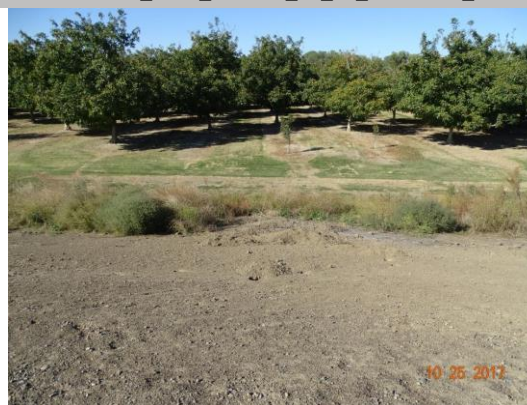
Photo 1 of 1 : SP\_2018\_LD0003\_27\_58\_20180305\_00037.jpg

LM Start	4.20	Rating **	U	Issue No.	58
LM End	4.20	Issue Type +	Ma	Location *	WS
Category	Earthen Levee			GPS Latitude/Longitude	
				Start	End
Item	Animal Control			39.429097 °	39.429097 °
				-121.987510 °	-121.987510 °
DWR ID	DWR_LD0003_01_f_2017_58				
Comment Code					
A3 : No rodents visible, but rodent burrows visible; need to backfill and compact or grout burrows.					
Inspector Comment					
Repair the rodent holes along the waterside slope.

View of the rodent holes along the waterside slope.

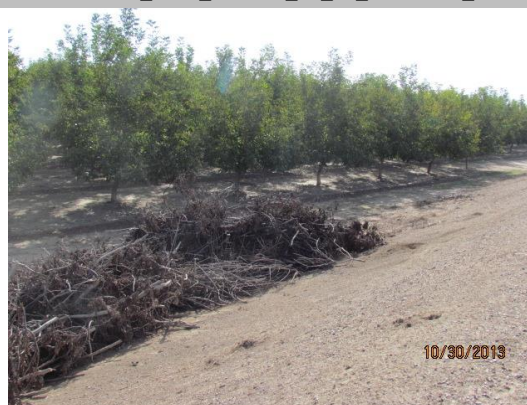
Photo 1 of 1 : SP\_2018\_LD0003\_27\_63\_20180305\_00042.jpg

View of the prunings along the landside toe.

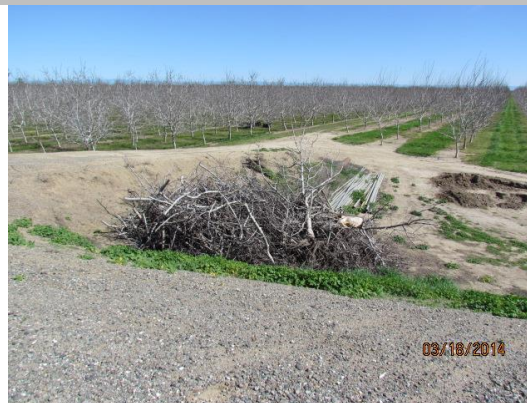
Photo 1 of 1 : SP\_2018\_LD0003\_27\_68\_20180305\_00046.jpg

View of the prunings along the landside toe.

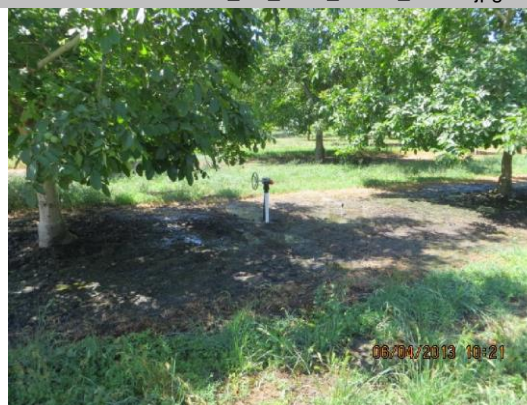
Photo 1 of 3 : UCIP\_SP\_2018\_15163\_24902.jpg

Possible shutoff valve on WS toe.

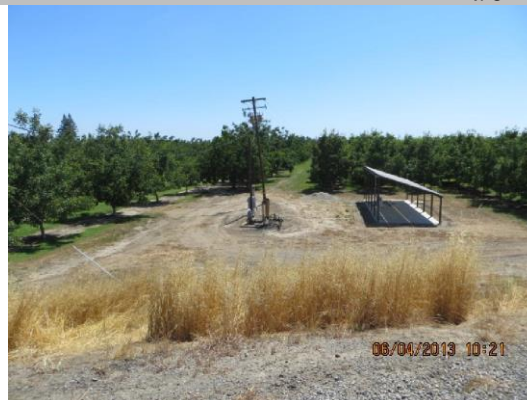
Photo 2 of 3 : UCIP\_SP\_2018\_15163\_24901.jpg

Pumping plant off LS toe.

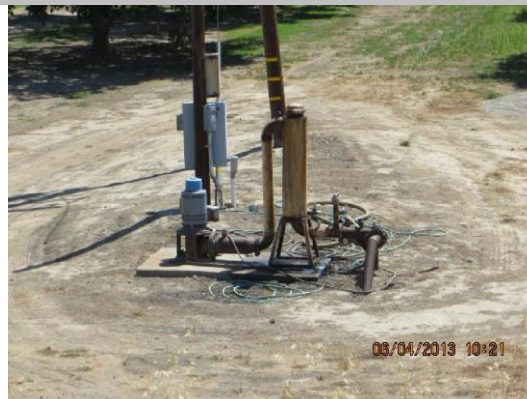
Photo 3 of 3 : UCIP\_SP\_2018\_15163\_24900.jpg

Pumping plant off LS toe.

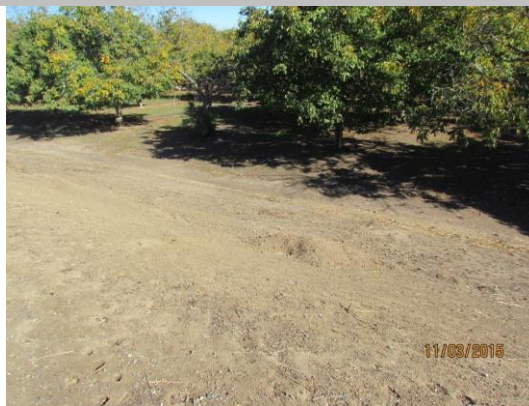
Photo 1 of 1 : SP\_2018\_LD0003\_27\_70\_20180305\_00048.jpg

View of the rodent holes along the landside slope.

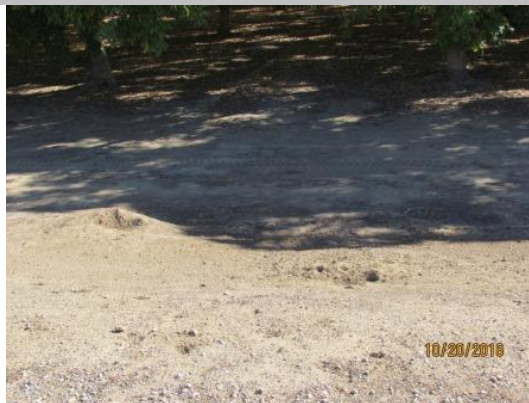
Photo 1 of 1 : SP\_2018\_LD0003\_27\_62\_20180305\_00041.jpg

View of the rodent holes along the landside slope.

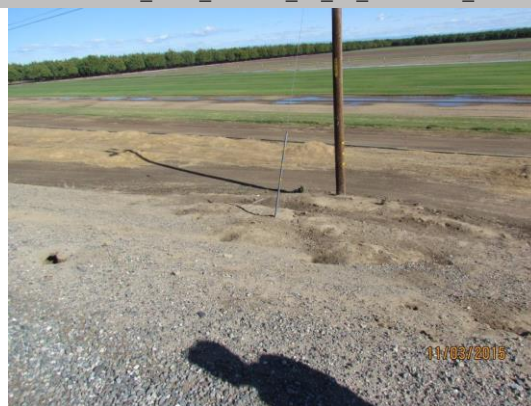
Photo 1 of 1 : SP\_2018\_LD0003\_27\_71\_20180305\_00049.jpg

View of the rodent holes along the landside slope.

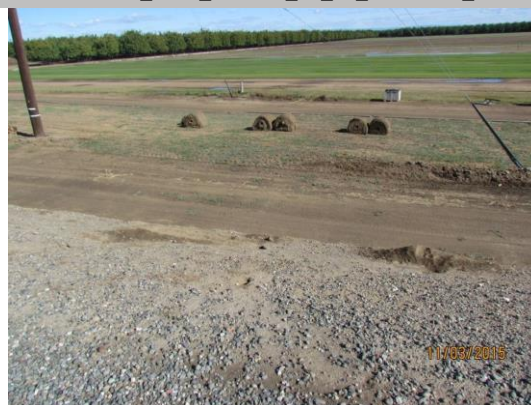
Photo 1 of 1 : SP\_2018\_LD0003\_27\_72\_20180305\_00050.jpg

View of the rodent holes along the landside slope.

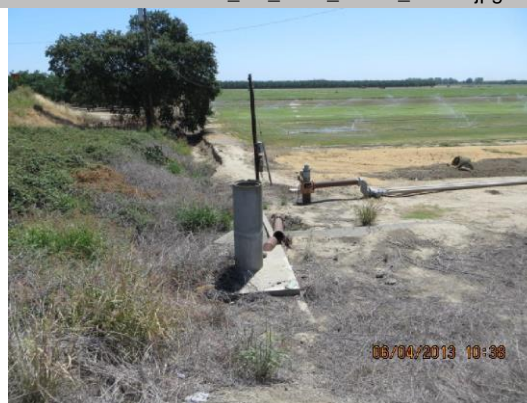
Photo 1 of 3 : UCIP\_SP\_2018\_14643\_24142.jpg

Concrete standpipe on LS toe.

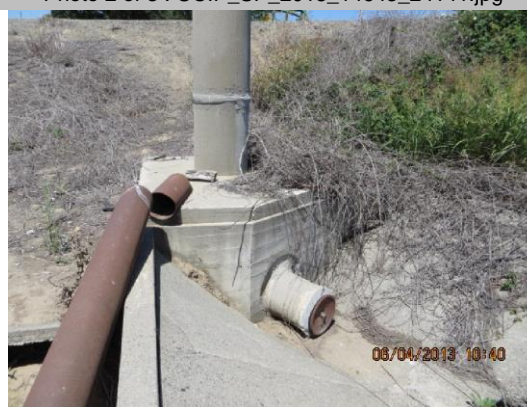
Photo 2 of 3 : UCIP\_SP\_2018\_14643\_24141.jpg

Concrete standpipe and channel on LS toe.

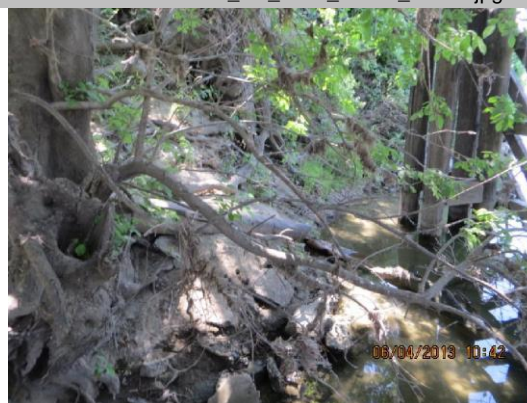
Photo 3 of 3 : UCIP\_SP\_2018\_14643\_24140.jpg

14-inch Pipe debris on WS toe.

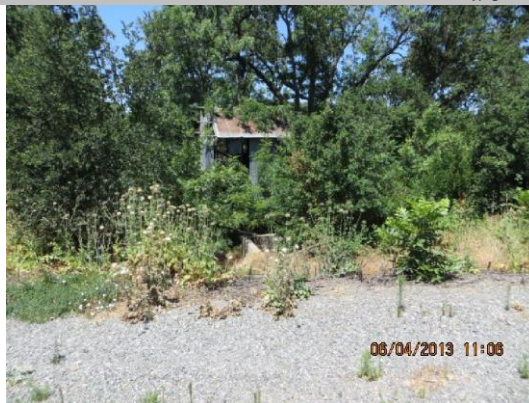
Photo 1 of 3 : UCIP\_SP\_2018\_14664\_24162.jpg

Pumphouse and 7'X12' concrete box on WS slope.

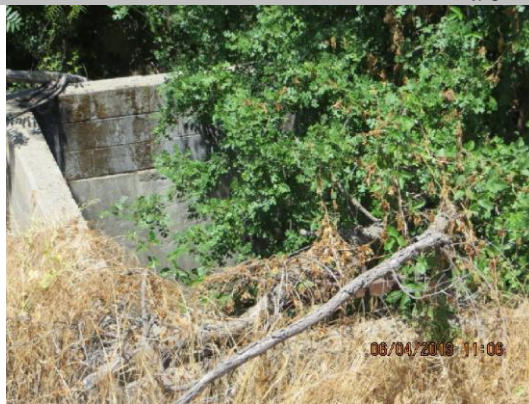
Photo 2 of 3 : UCIP\_SP\_2018\_14664\_24161.jpg

7'X12' Concrete box with flap gate and slide gate on WS slope.

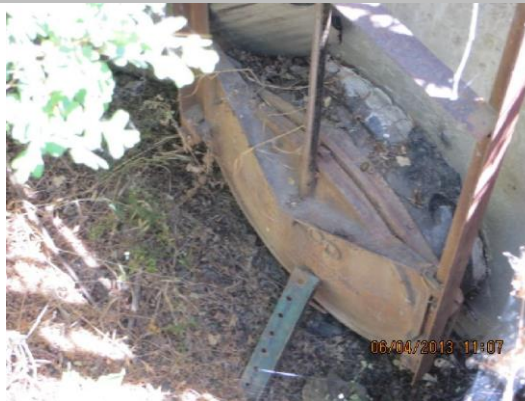
Photo 3 of 3 : UCIP\_SP\_2018\_14664\_24160.jpg

Slidegate inside concrete box on WS slope.

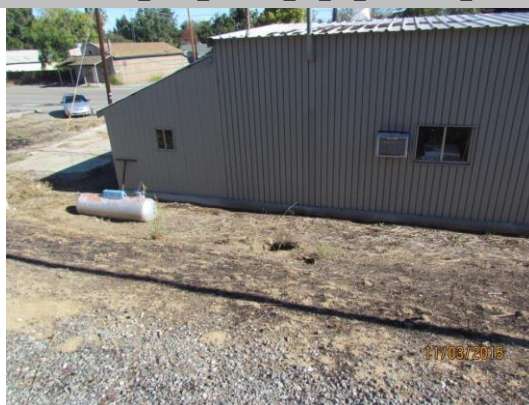
Photo 1 of 1 : SP\_2018\_LD0003\_27\_76\_20180305\_00053.jpg

View of the burned out stump hole along the landside toe.

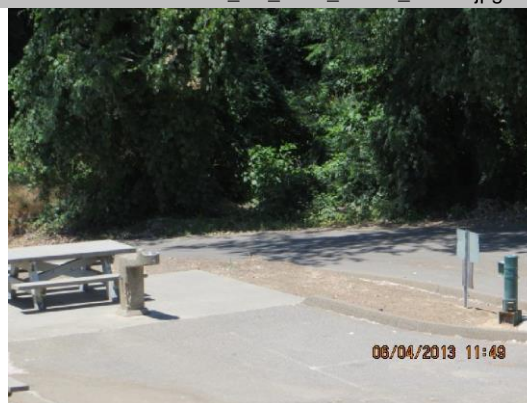
Photo 3 of 3 : UCIP\_SP\_2018\_15165\_24904.jpg

Possible reason for water service (water fountain).

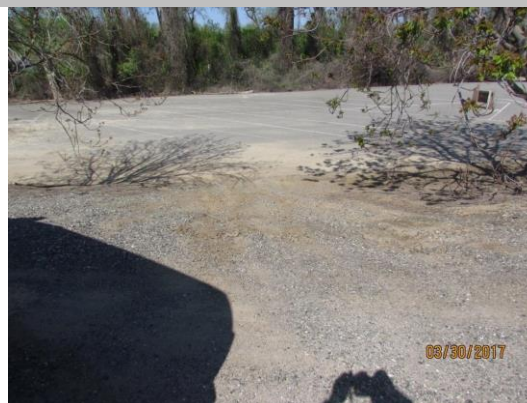
Photo 1 of 1 : SP\_2018\_LD0003\_27\_97\_20180305\_00063.jpg

View of the vehicle ruts on the waterside slope.

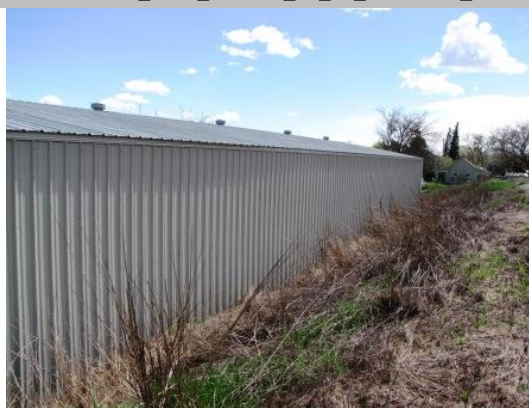
Photo 1 of 1 : SP\_2018\_LD0003\_27\_42\_20180305\_00022.jpg

View of the building along the landside toe.

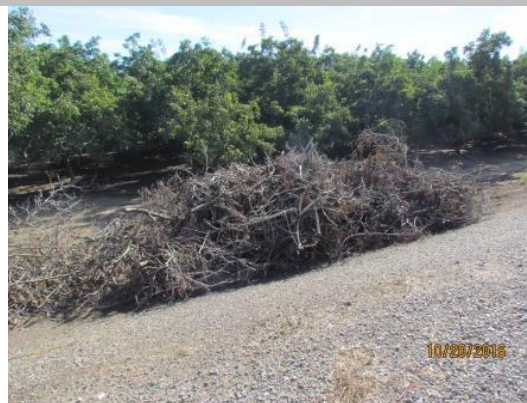
Photo 1 of 1 : SP\_2018\_LD0003\_27\_95\_20180305\_00061.jpg

View of the prunings along the landside toe.

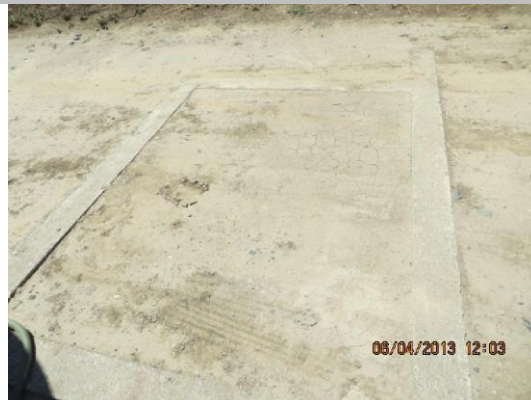
Photo 2 of 2 : UCIP\_SP\_2018\_14686\_24183.jpg

Soil filled concrete distribution box on LS toe.

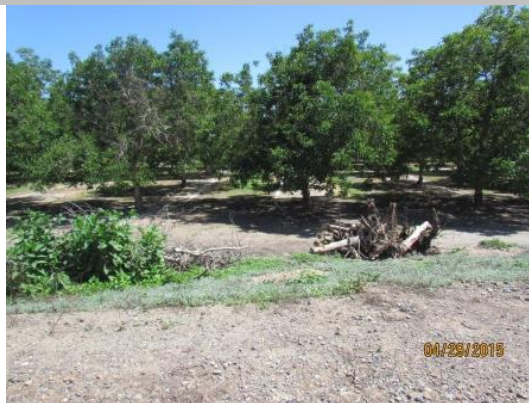
Photo 1 of 1 : SP\_2018\_LD0003\_27\_37\_20180305\_00020.jpg

View of the prunings along the landside slope.

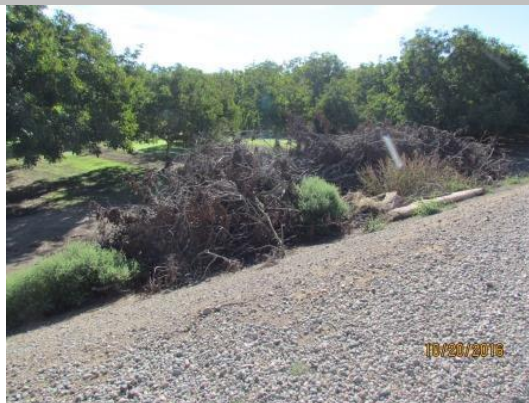
Photo 1 of 1 : SP\_2018\_LD0003\_27\_61\_20180305\_00040.jpg

View of the pruning along the landside toe.

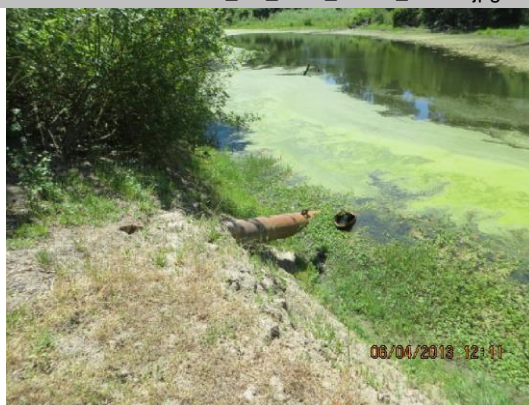
Photo 1 of 3 : UCIP\_SP\_2018\_14687\_24187.jpg

Pipe visible at pond off WS toe.

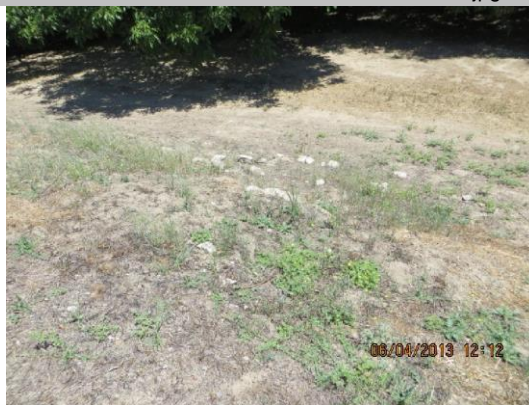
Photo 3 of 3 : UCIP\_SP\_2018\_14687\_24185.jpg

Remnants of concrete distribution box on LS toe.

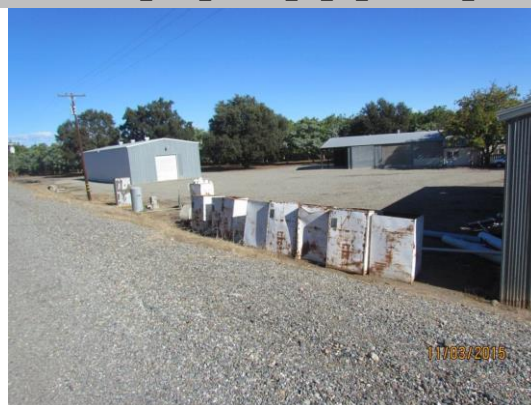
Photo 1 of 1 : SP\_2018\_LD0003\_27\_77\_20180305\_00054.jpg

View of the metal boxes along the landside toe.

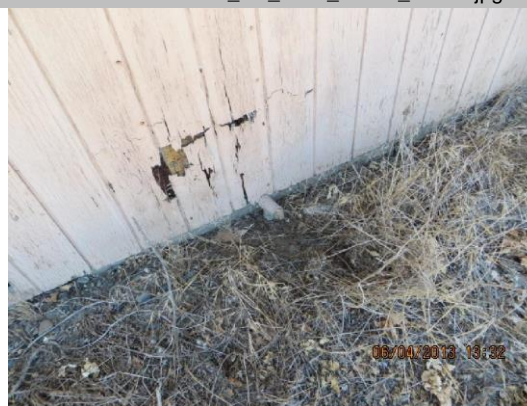
Photo 1 of 3 : UCIP\_SP\_2018\_14688\_24190.jpg

Pipe at side of building on WS shoulder.

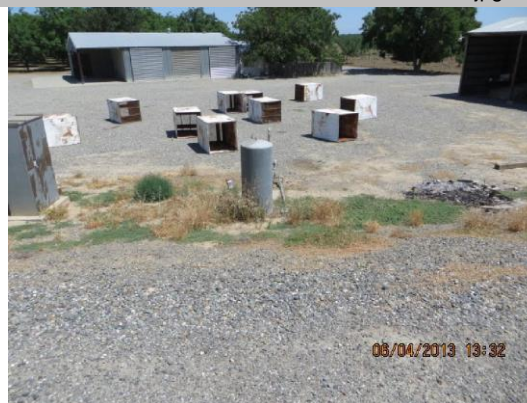
Photo 2 of 3 : UCIP\_SP\_2018\_14688\_24189.jpg

Water tank, pump, and well head on LS toe.

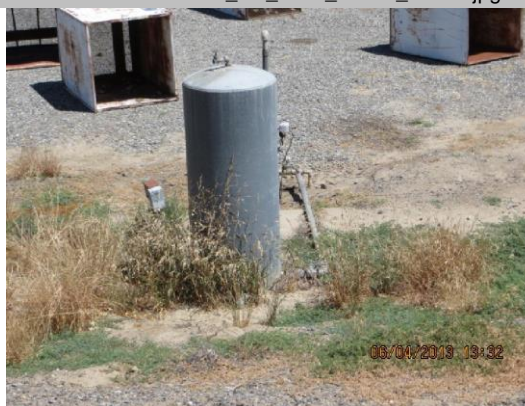
Photo 3 of 3 : UCIP\_SP\_2018\_14688\_24188.jpg

Water tank, pump, and well head on LS toe.

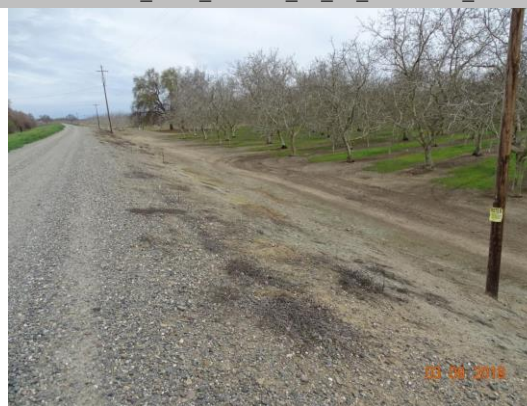
Photo 1 of 1 : SP\_2018\_LD0003\_27\_78\_20180312\_00111.jpg

View of the rodent holes along the landside slope.

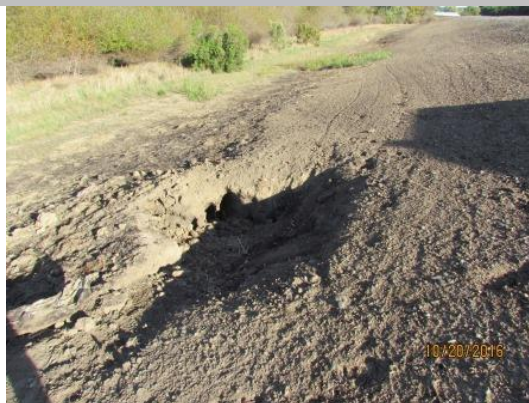
Photo 1 of 1 : SP\_2018\_LD0003\_27\_89\_20180305\_00057.jpg

View of a hole along the waterside slope that need to be backfilled and compacted.

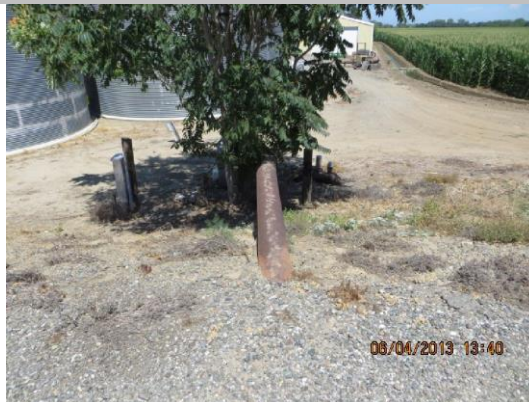
Photo 3 of 3 : UCIP\_SP\_2018\_14690\_24191.jpg

10-inch pipe on LS.
